## Windstorm Mitigation Report

Village On The Green Condominium II

Clearwater, FL

As of 3/18/2022 | FPAT File# MUD2216945

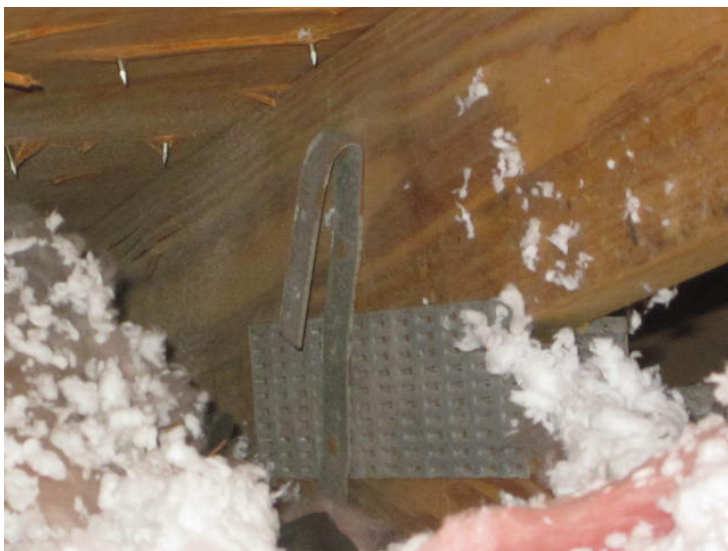
## Roof Construction

| <b>2. Roof Covering:</b><br>Comments: | <b>FBC Equivalent</b><br>The roof covering was replaced in 2006. The roof permit was confirmed and the permit number is BCP2006-12166. This roof was verified as meeting the building code requirements outlined on the mitigation affidavit. |

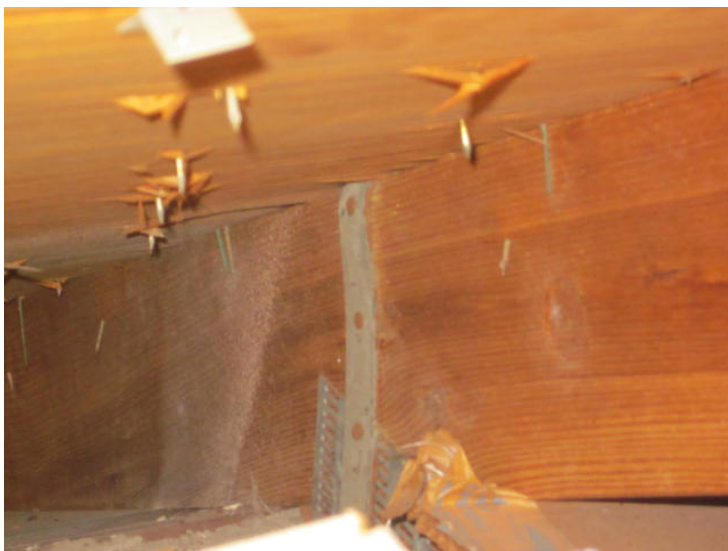
## Roof Construction

| <b>2. Roof Covering:</b><br>Comments: | <b>FBC Equivalent</b><br>The roof covering was replaced in 2006. The roof permit was confirmed and the permit number is BCP2006-10227. This roof was verified as meeting the building code requirements outlined on the mitigation affidavit. |

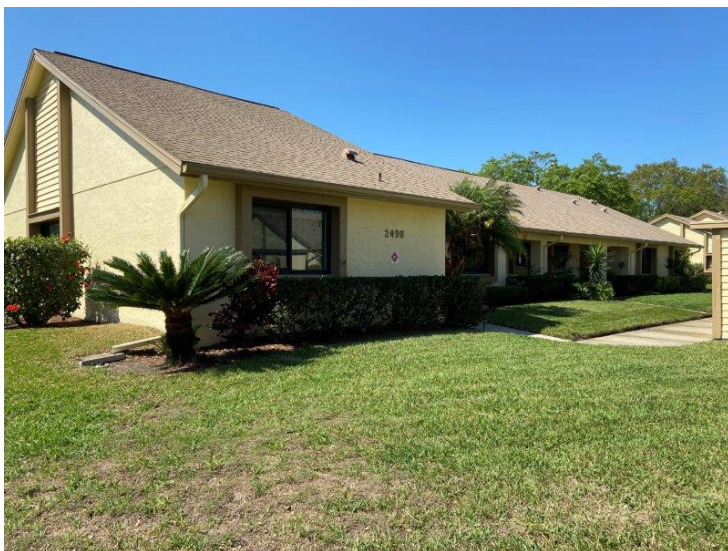
## Roof Construction

| <b>2. Roof Covering:</b><br>Comments: | <b>FBC Equivalent</b><br>The roof covering was replaced in 2006. The roof permit was confirmed and the permit number is BCP2006-12168. This roof was verified as meeting the building code requirements outlined on the mitigation affidavit. |

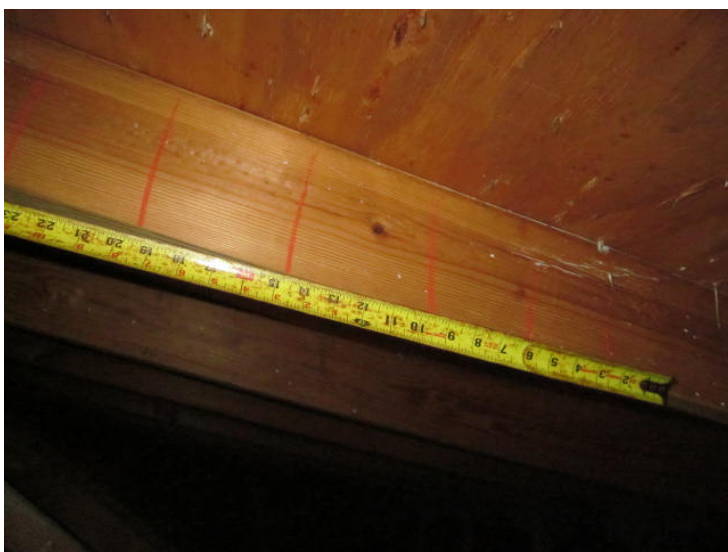
Roof Construction

| <b>2. Roof Covering:</b><br>Comments: | <b>FBC Equivalent</b><br>The roof covering was replaced in 2006. The roof permit was confirmed and the permit number is BCP2006-12548. This roof was verified as meeting the building code requirements outlined on the mitigation affidavit. |
